Energy-Efficient Rehabilitation of Multifamily Buildings in the Midwest

by J.T. Katrakis, P.A. Knight, and J.D. Cavallo

Policy and Economic Analysis Group,
Decision and Information Sciences Division,
Argonne National Laboratory, 9700 South Cass Avenue, Argonne, Illinois 60439

September 1994

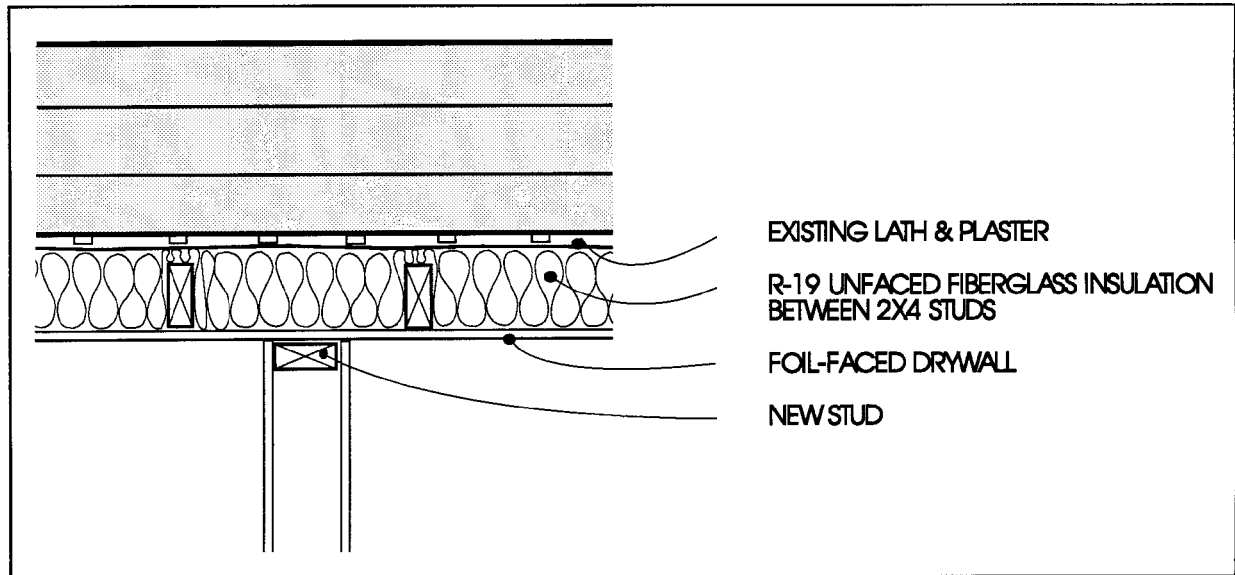
FIGURE 2 Typical Exterior Wall with Interior Partition (Interior partition framing is pulled away from the exterior wall to allow for installation of insulation. Continuous drywall behind the partition wall provides an air barrier.)

The objective of sidewall insulation is to provide a continuous thermal break between the interior and exterior (Figure 2). The key word is "continuous." Insulation can be placed behind corner studs of interior partition walls, thereby maintaining the continuity of the insulation and providing a thermal break between the interior and exterior. However, it is impossible to make this same break between an interior masonry wall and the exterior wall. These interior masonry walls provide bearing for floors and ceilings and are common in masonry multifamily buildings. These walls act as "fins" by wicking heat to the outside. This problem is not addressed in typical multifamily building rehab projects.

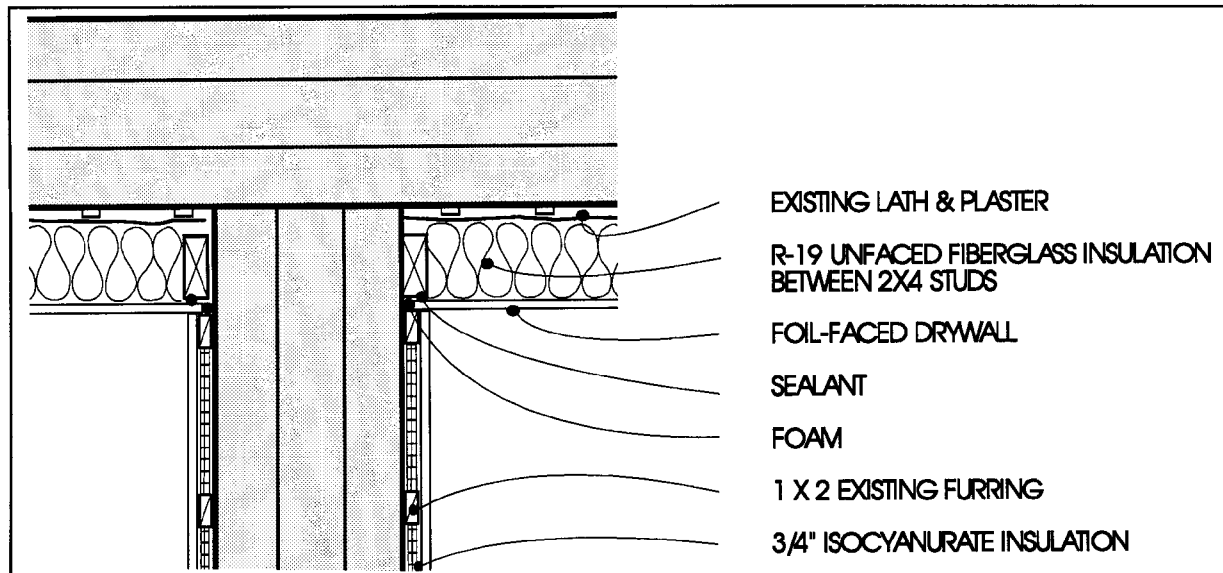
FIGURE 3 Typical Exterior Wall with Existing Bearing Wall (fin wall) (Fin wall is insulated with 0.75-in. rigid insulation between existing furring strips. Sealing the first furring strip to the fin wall provides an air barrier.)

"Fin" walls are unique to masonry structures. No references could be found that describe how to solve the heat bypass problem. Thus, the system shown in Figure 3 was developed for the SI program.

Typically, the plaster and lath on fin walls are also removed in a gut rehab. The furring strips often remain on the wall and serve as a nailer for new drywall. The first 4 to 6 ft on the heated sides of the fin wall is insulated with 0.75-in. polyisocyanurate insulation following removal of the plaster and lath. The 0.75-in. insulation is used for two reasons. First, it fits neatly between the existing furring strips — the fin wall does not have to be framed as do the exterior walls. Second, it has a higher R-value per inch (7.2) than do other rigid insulation systems.

Just as the fin wall presented a special insulation problem, it also presents an air-sealing problem. Caulk or foam is used to seal the furring strip adjacent to the exterior wall to prevent air movement into the fin wall (Figure 3).

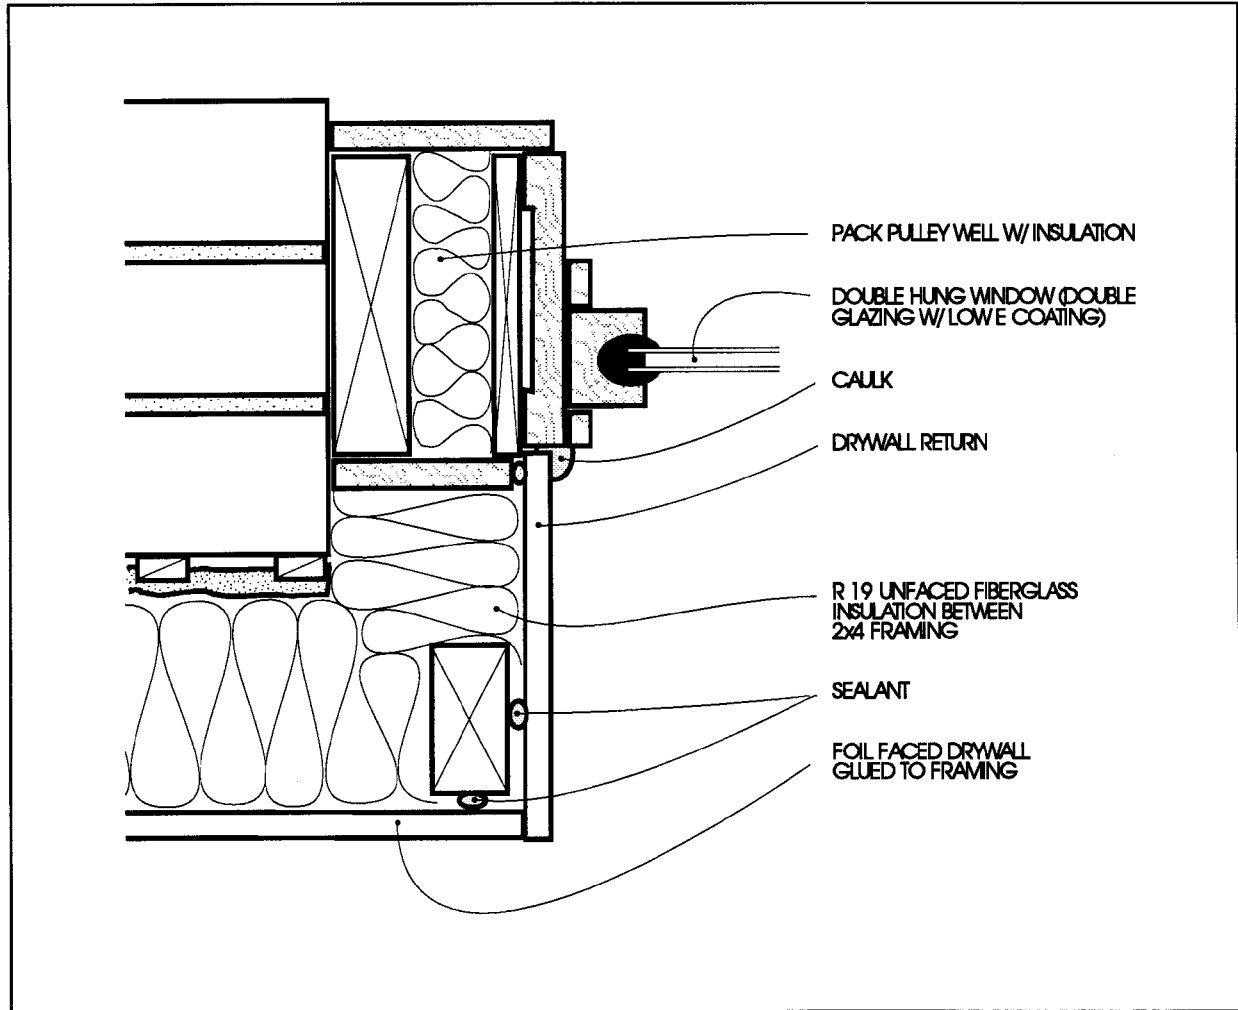
FIGURE 4 Existing Pulley Well Packed with Insulation (Drywall returns are insulated and sealed to the window frame.)

Pulley wells are packed with insulation. Spaces between the window and rough opening are stuffed with insulation and/or foamed as shown in Figures 4 and 5. Wood mullions between windows are also insulated.

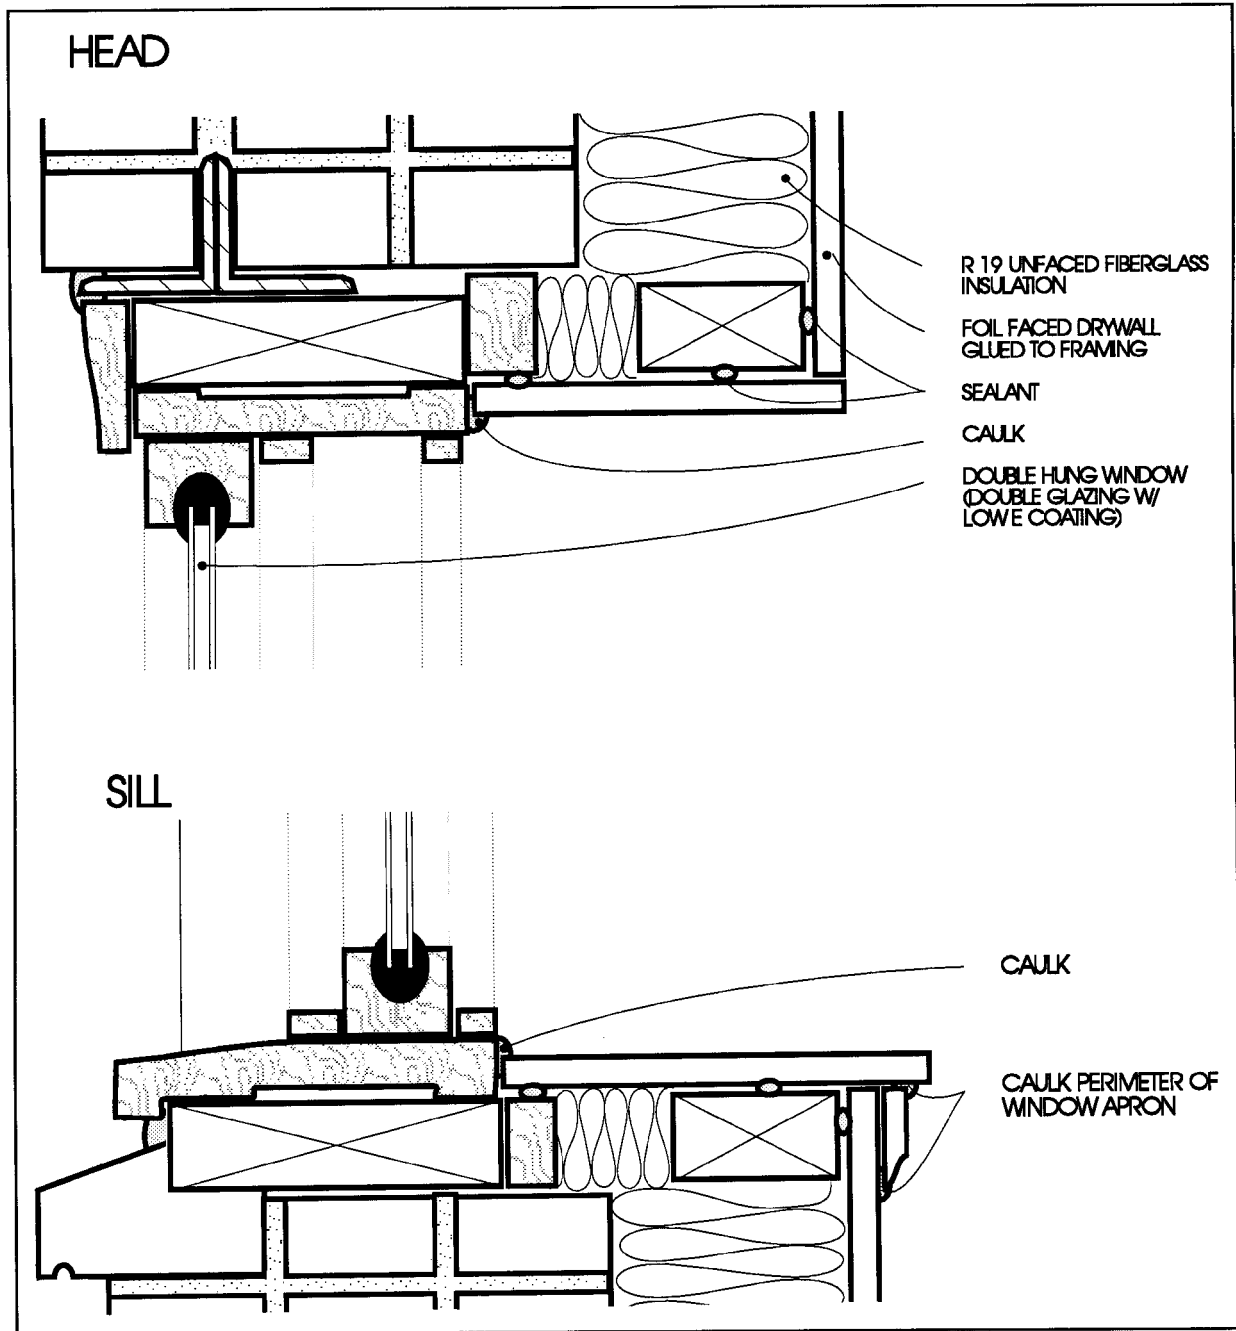
**FIGURE 5 Window Head and Sill Insulated and Sealed to the Window Frame
(Window stool and apron are sealed to the framing and drywall.)**

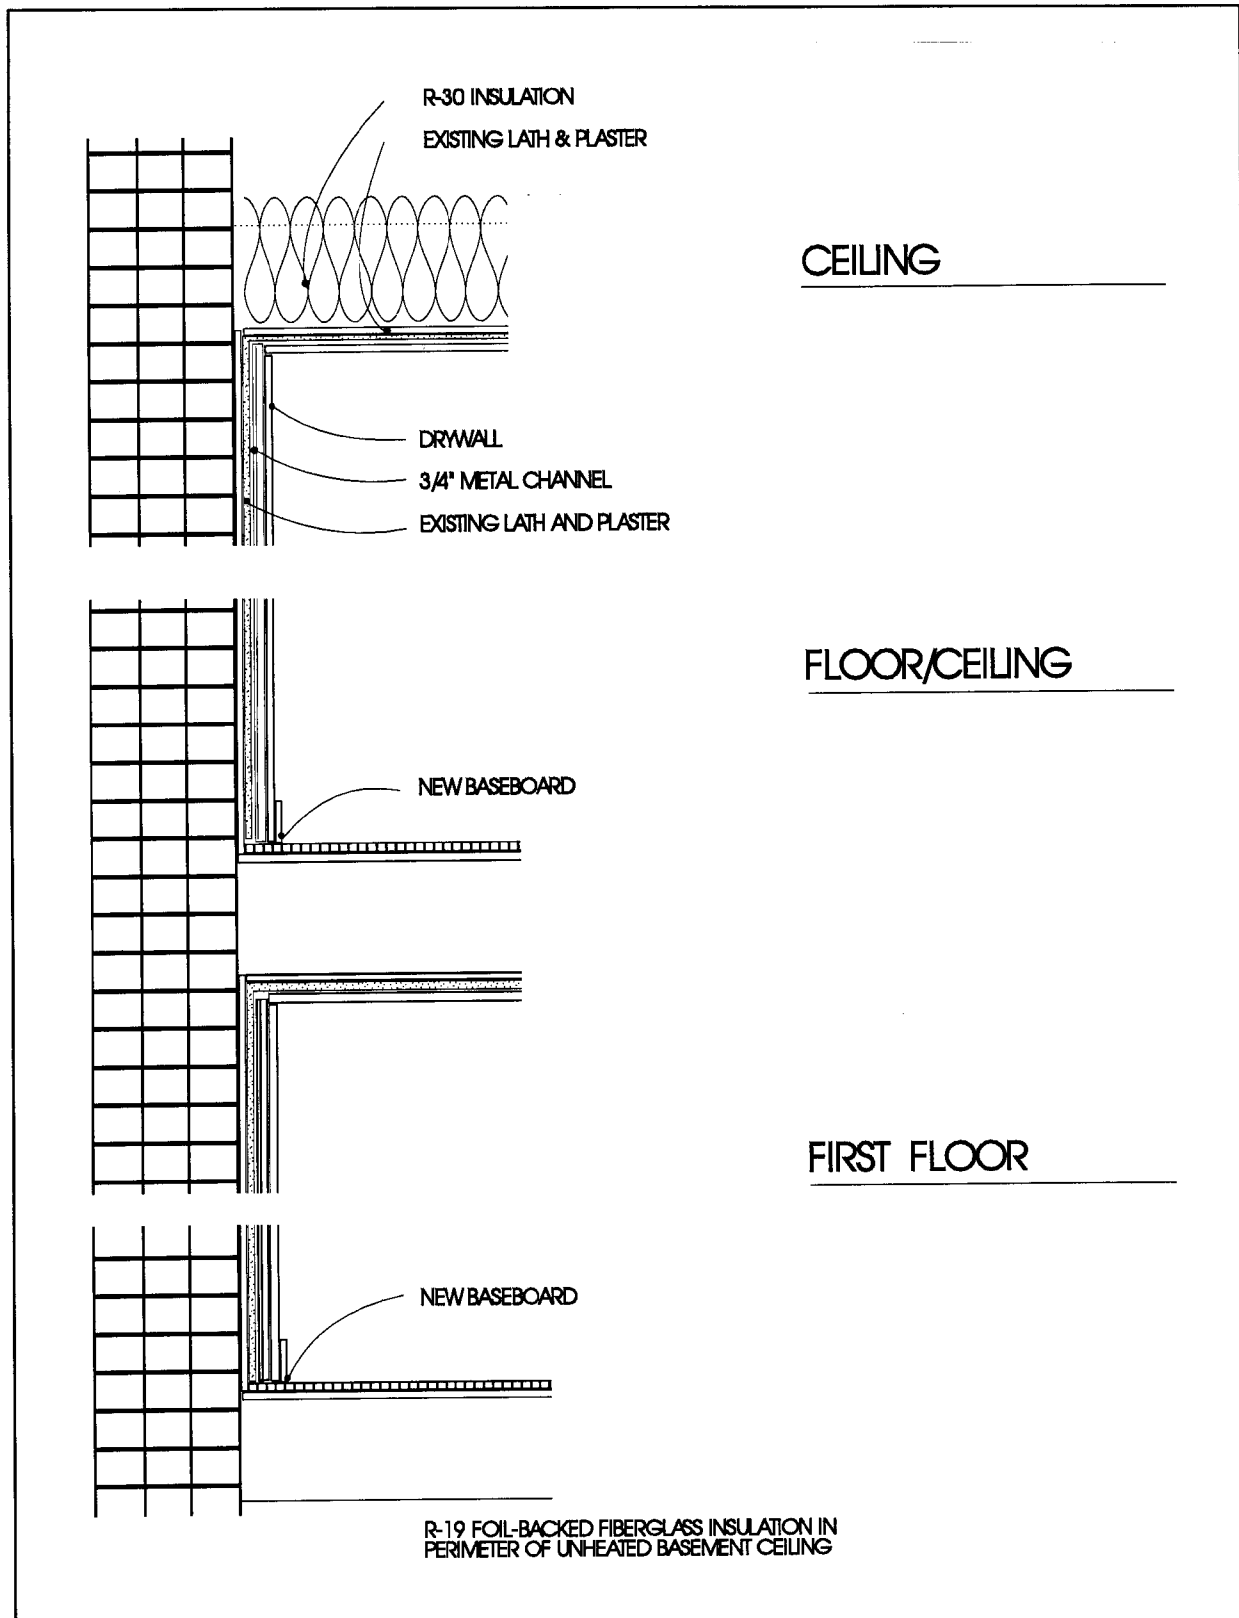
FIGURE 6 Wall Section Used in the 4737 S. Ingleside Building where Existing Plaster and Lath Remained

Original plans called for installing 0.75-in. metal channels over the existing plaster and lath on all exterior walls and attaching drywall to the framing (Figure 6). This may be considered standard practice in a "typical" rehab. However, it was decided during the course of construction that much of the plaster and lath had to be removed before the metal framing could be installed, particularly in the bathrooms. In these cases, 0.75-in. metal channels were installed vertically to the masonry at about 24-in. on center. The same size metal framing was then installed horizontally across the vertical members to provide a flush surface for installing the drywall where framing was installed over the plaster and lath. This framing system gave the wall a "checkerboard" pattern (Figure 7).

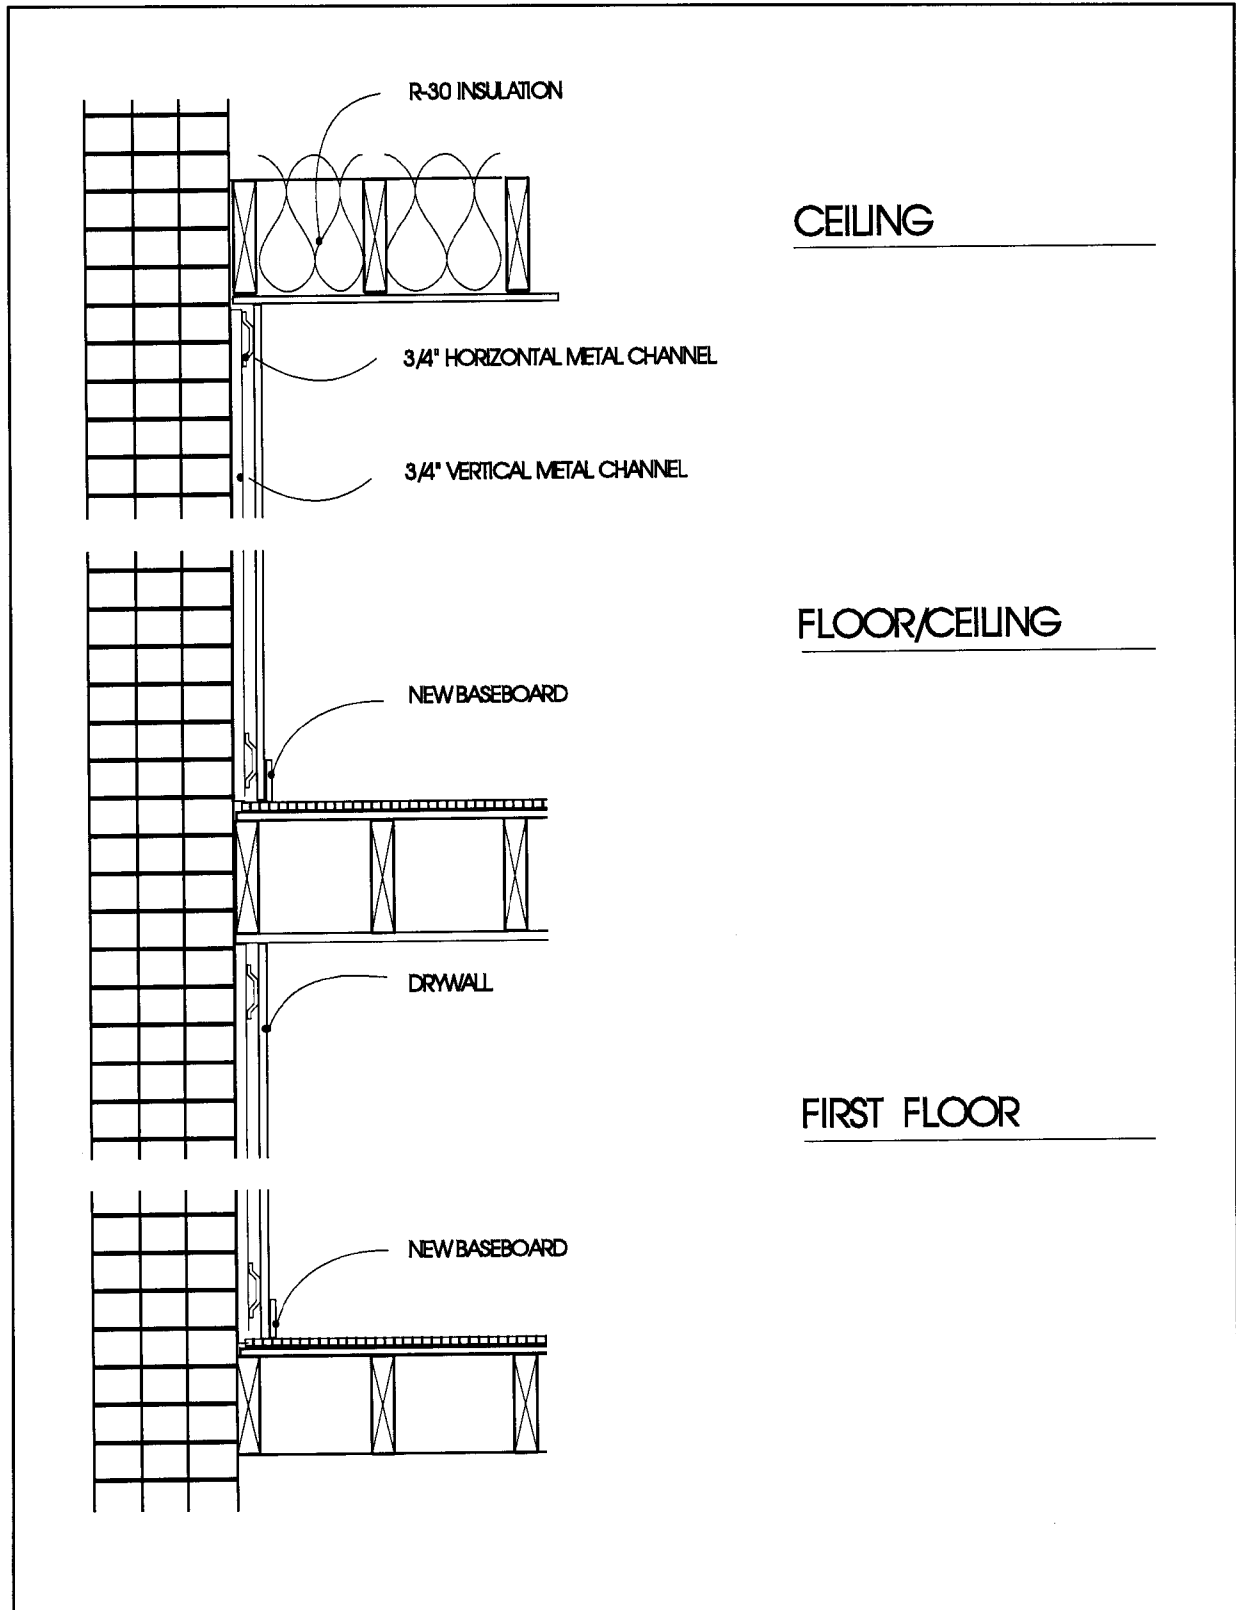
FIGURE 7 Wall Section Used in the 4737 S. Ingleside Building where Existing Plaster and Lath Were Removed

The framing was installed on average about 1 in. away from the masonry wall to move the new wall away from all irregularities on the wall surface. The top and bottom plates were attached to the ceiling joists and subfloor, respectively. This is a typical framing practice where 2×4 framing is used in a masonry rehab project (Figure 8). R-19 (6-in.) insulation was chosen to completely fill the cavity. A standard 3.5-in. batt (R-11, 13, or 15) would leave a 1-in. air space between the insulation and exterior wall, which would allow for the establishment of convective currents. Although there is some compression of the batt (therefore not achieving the full R-19), it is believed the trade-off to completely sealing the cavity outweighs the slight loss of R-value.

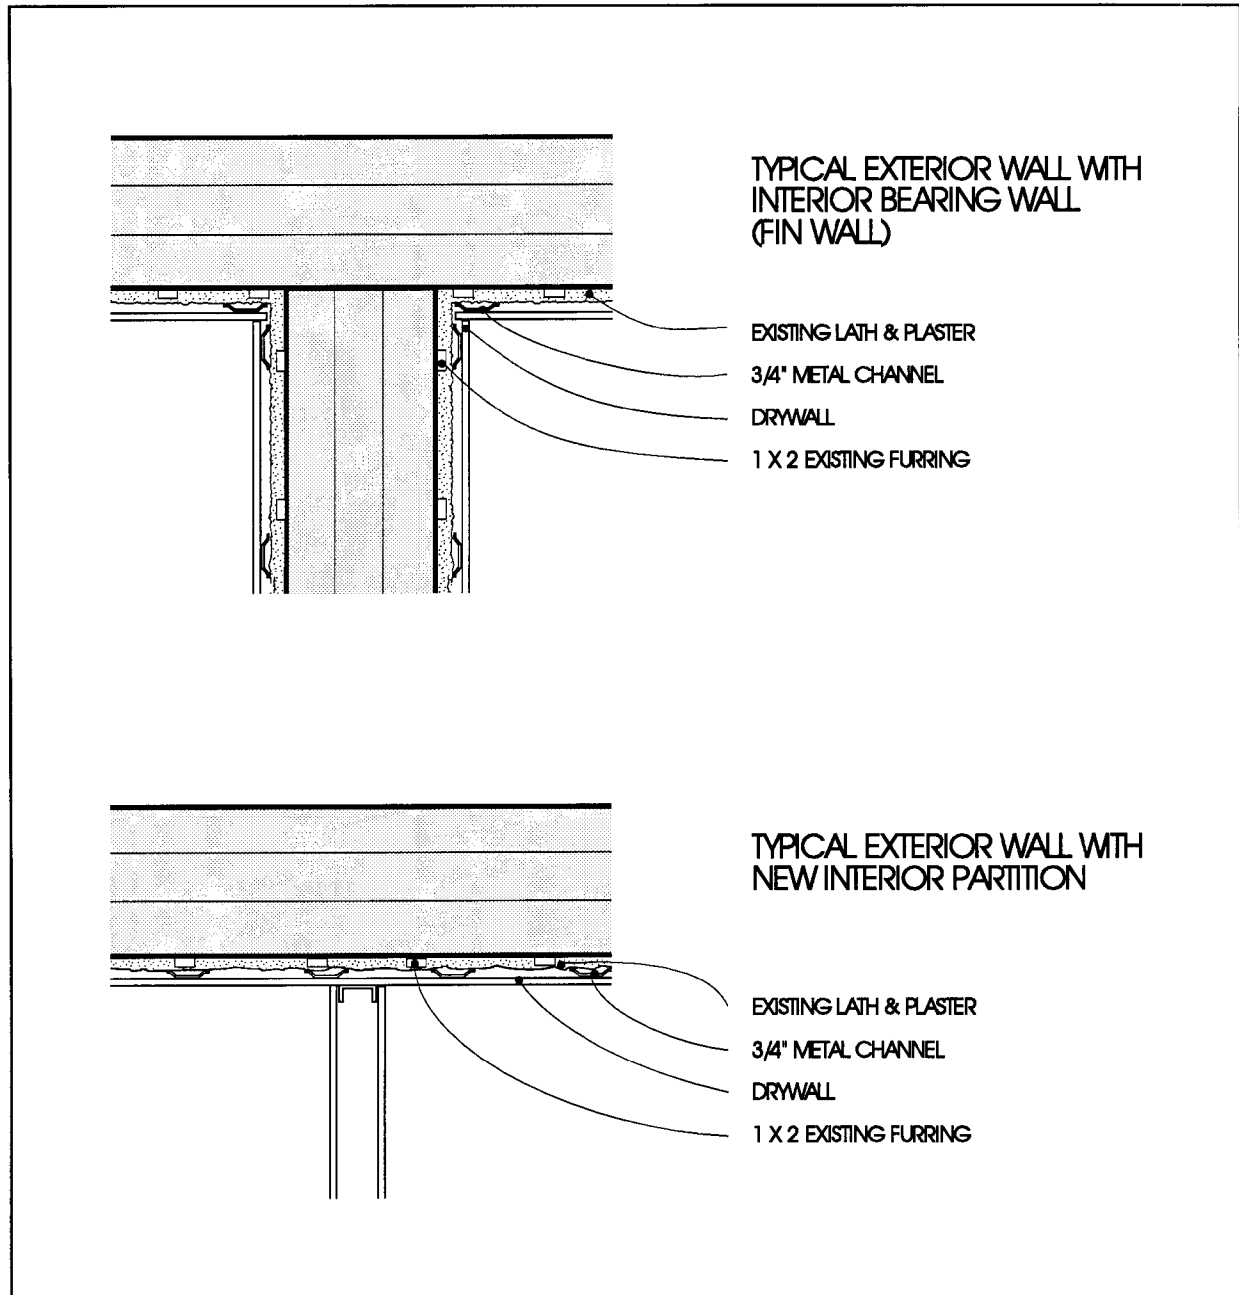
FIGURE 9 Plan View of "Fin" Wall and New Interior Partition Wall Used in the 4737 S. Ingleside Building

One masonry interior bearing wall extends the length of the 4737 building from front to back. The plaster and lath were not removed from the fin walls. However, 0.75-in. metal channels were installed over the plaster and lath for new drywall installation. The fin walls were not air sealed or insulated before drywall installation (Figure 9).

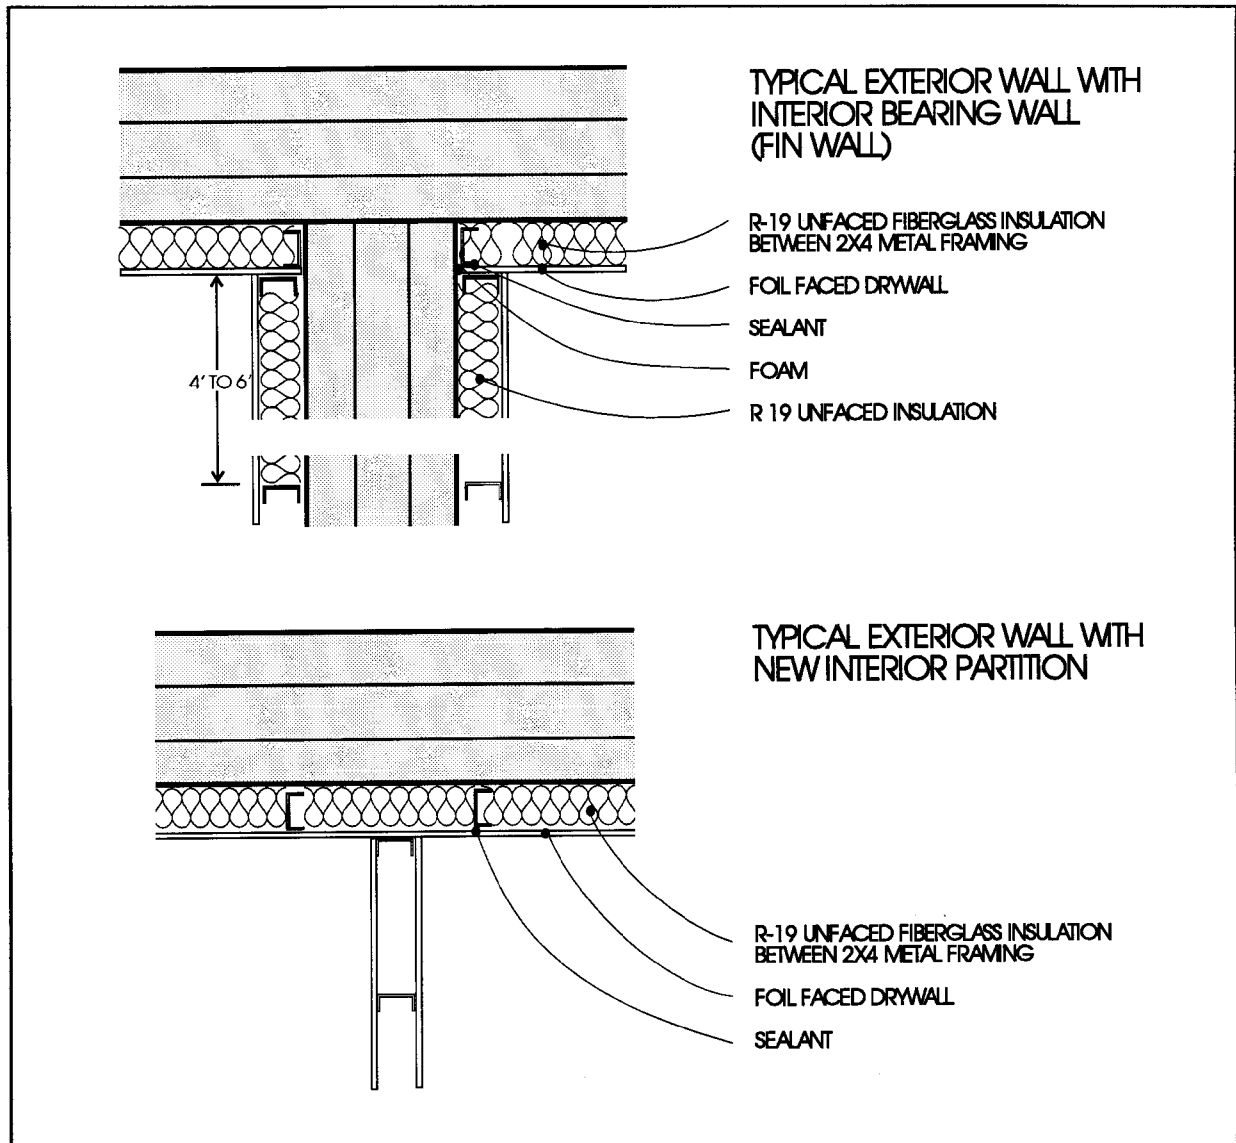
FIGURE 10 Plan View of "Fin" Wall and New Interior Partition Wall Used in the 4746 S. Ingleside Building

The entire fin wall was framed with 2×4 metal framing in the same fashion as for the exterior walls; that is, the framing was pulled away from the masonry. Consequently, the wall was also insulated with R-19 down to a point 6 ft away from the exterior wall. The insulation cost \$0.45/ft² (Figure 10).
